**Flood Control Project Maintenance
Levee Inspections**
LMA District Cover Sheet
Spring 2017 Levee Inspection Results

Reclamation District No. 0369 Libby McNeil

Spring 2017 Levee Inspection Results

Waterway			Bank	Unit Miles
Unit No. 01 Sacramento River			Left	0.78
	Spring (March - May)	Summer (June - August)	(September - November) Fall	Winter (December - February)
Unit Maintenance Rating (Fall Only)				
Date of Inspection	4/4/2017 - 4/4/2017			
DWR Inspector	Herman Phillips			
Accompanied By	Clarence Chu RD 369

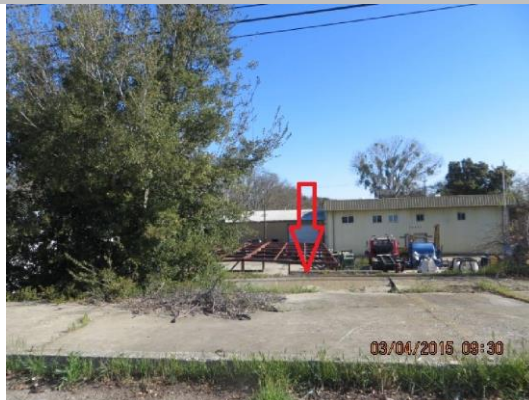
Comment Code						
Inspector Comment						
FS_ID:50105 DS_ID:18971 EP_NO: 8555 Repair Type: Non-Urgent Crossing Status: Found UCIP Comments: 03/04/2015 Pipe corroded through on LS at retaining wall. May not go all the way through the levee. Appears abandoned and if so should be done so properly. FIELD_STRUCT_DESC: *ABANDONED* 2 of 2: 4-inch steel pipe through the levee with an unknown purpose, 4 feet below the crown. Pipe visible on the landside (LS) at a retaining wall (Automatic Board Order (ABO) issued as Permit No. 8555, 1973 - Jordan Investment Co.). [Additional Reference(s): DWR Levee Log, 2002. USACE Sacramento O&M Manual 111, May 1959 (RM 28.87)]. FS Date: 3/4/2015 4:11:00 PM

Pipe visible on retaining wall at LS toe.

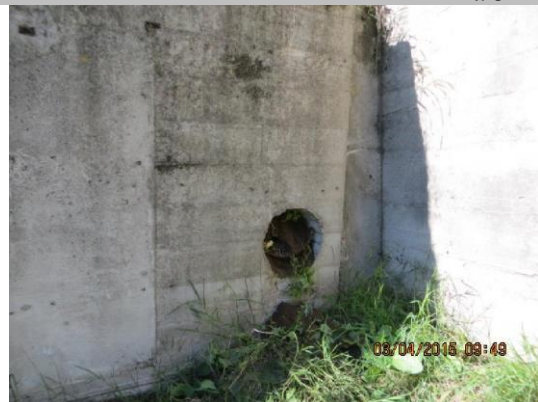
Photo 1 of 3 : UCIP_SP_2017_43811_73162.jpg

LM Start	0.05	Rating **	M	Issue No.	30
LM End	0.05	Issue Type +	En	Location *	LS
Category	Supplemental			GPS Latitude/Longitude	
				Start	End
Item	DWR UCIP Field Study			38.258347 °	38.258347 °
				-121.517169 °	-121.517169 °
DWR ID					
Comment Code					
Inspector Comment					
FS_ID:43811					
DS_ID:18970					
EP_NO: N/A					
Repair Type: Non-Urgent					
Crossing Status: Found					
UCIP Comments: 03/04/2015 Pipe appears abandoned and is filled with soil. Appears abandoned and if so should be done so properly.					
FIELD_STRUCT_DESC: *ABANDONED* 8-inch steel drainage pipe through the levee, 8 feet below the crown. Hole in concrete retaining wall on the landside (LS) slope measures 10 inches in diameter.					
[Additional Reference(s): DWR Levee Log, 2002].					
FS Date: 3/4/2015 4:41:00 PM

10-inch hole in concrete retaining wall likely for this pipe. Visible on LS toe. Portion of pipe visible.

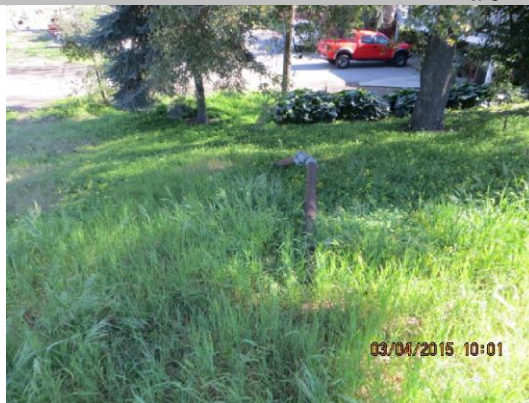
Photo 1 of 3 : UCIP_SP_2017_50158_73331.jpg

FS_ID:50158
DS_ID:25084
EP_NO: N/A
Repair Type: Urgent
Crossing Status: Found
UCIP Comments: 06/01/2016 Same as last inspection. (K. Fazel - UCIP)03/04/2015 Severe corrosion and holes visible in pipe on LS shoulder. Pipe appears abandoned and should be done so properly. (W. Wyle - FPIIB)
FIELD_STRUCT_DESC: *ABANDONED* 4-inch steel pipe through the levee, of an unknown purpose, 1 foot below the crown. Pipe is visible on the landside (LS) slope just in front of the gate on the LS shoulder.
[Additional Reference(s): USACE Sacramento O&M Manual 111, May 1959 (RM 27.87)].
FS Date: 6/1/2016

Pipe visible on LS slope.

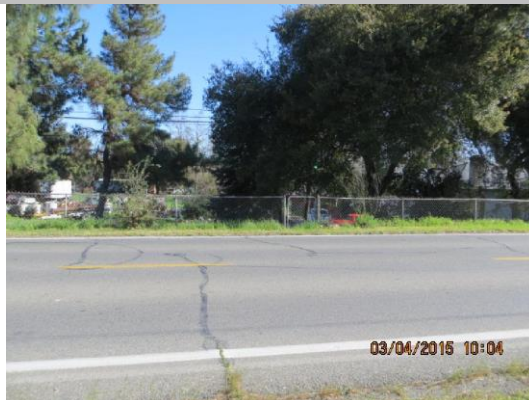
Photo 2 of 3 : UCIP_SP_2017_50158_73332.jpg

Pipe visible at gate on LS shoulder.

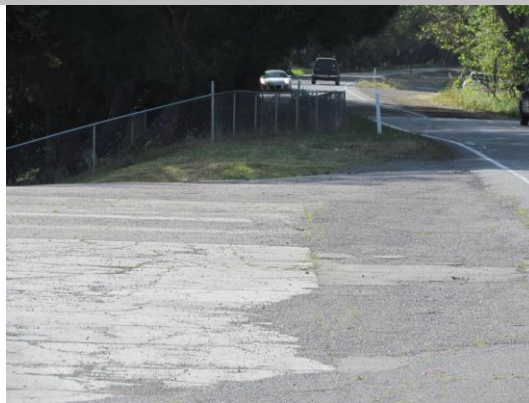
Photo 1 of 1 : SP_2017_RD0369_207_10_20170405_00021.jpg

LM Start	0.16	Rating **	M	Issue No.	10
LM End	0.23	Issue Type +	Ma	Location *	LS
Category	Earthen Levee			GPS Latitude/Longitude	
				Start	End
Item	Vegetation			38.257292 °	38.256660 °
				-121.515690 °	-121.514710 °
DWR ID	DWR_RD0369_01_s_2017_10				
Comment Code					
V2 : Remove the wild growth other than native grasses from the levee slopes.					
Inspector Comment					
Spray or mow the weeds along the landside levee slope.

Looking downstream from the landside shoulder.

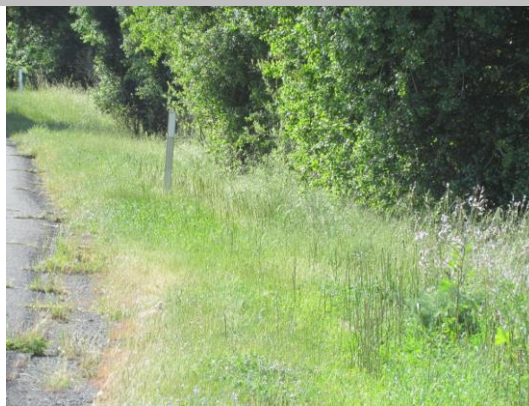
Photo 1 of 1 : SP_2017_RD0369_207_9_20170405_00022.jpg

LM Start	0.16	Rating **	M	Issue No.	9
LM End	0.57	Issue Type +	Ma	Location *	WS
Category	Earthen Levee			GPS Latitude/Longitude	
				Start	End
Item	Vegetation			38.257292 °	38.252597 °
				-121.515690 °	-121.511130 °
DWR ID	DWR_RD0369_01_s_2017_9				
Comment Code					
V2 : Remove the wild growth other than native grasses from the levee slopes.					
Inspector Comment					
Spray the weed growth along the waterside levee slope.

Looking downstream from the waterside shoulder.

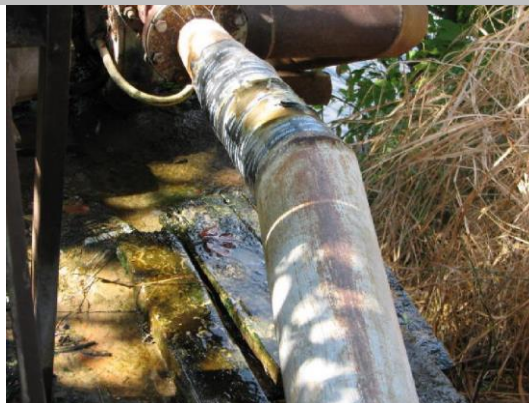
Photo 2 of 3 : UCIP_SP_2017_43814_10456.jpg

Waterside view: water leaking pump station.

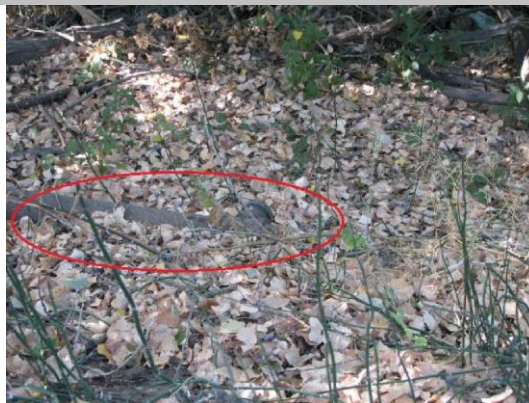
Photo 2 of 2 : UCIP_SP_2017_43815_73300.jpg

Pipe on WS slope running parallel to levee crown.

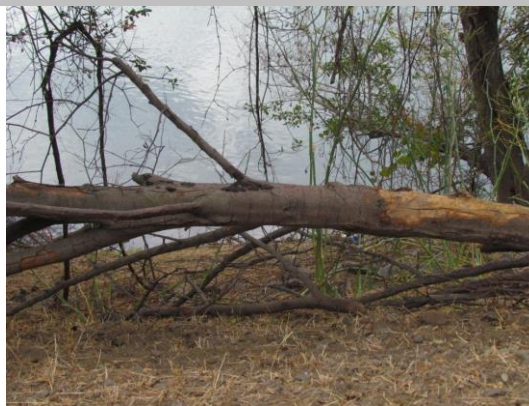
Photo 1 of 1 : SP_2017_RD0369_207_16_20170404_00002.jpg

LM Start	0.53	Rating **	M	Issue No.	16
LM End	0.53	Issue Type +	Ma	Location *	WS
Category	Earthen Levee			GPS Latitude/Longitude	
				Start	End
Item	Encroachments			38.253095 °	38.253095 °
				-121.511387 °	-121.511387 °
DWR ID	DWR_RD0369_01_s_2016_16				
Comment Code					
TR : Tree or limb					
Inspector Comment					
Cut up and remove the dead tree from the waterside slope. This tree was reported during spring inspection 2016.

RD 369 Levee mile 0.53 waterside levee slope.

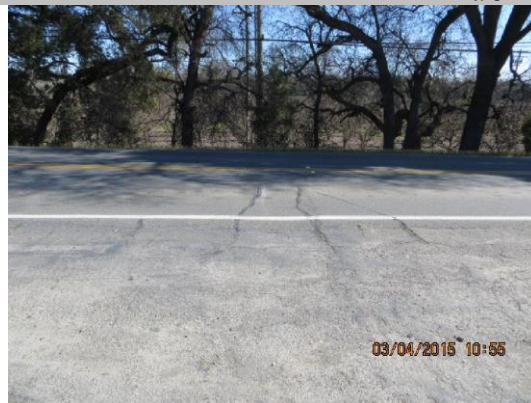
Photo 1 of 3 : UCIP_SP_2017_50159_73166.jpg

FS_ID:50159
DS_ID:18977
EP_NO: 14313
Repair Type: Urgent
Crossing Status: Indicator Found
UCIP Comments: 06/01/2016 Could not locate pipe. Likely buried next to leach box. Could not find signs of leaking or presence of water or erosion. Pipe may still be leaking but buried. (K. Fazel - UCIP)03/04/2015 Septic line appears to be leaking at LS toe. Erosion of soil and wet soil visible at LS toe. No septic smell accompanied other evidence at site. (W. Wylie - FPIIB)
FIELD_STRUCT_DESC: 3 of 3: 2-inch galvanized steel sewer pipe through the levee, 1 foot below the crown. A metal cutoff placed around the pipe near the centerline of the levee. 4-foot by 6-foot concrete box at the landside (LS) toe. Pipe runs through the district president, Clarence Chu's property: ckchu52@comcast.net 916-776-1684, 916-813-7037. (Permit No. 14313, 1986 - Schmiedel) (Additional Related Permit(s): Permit No. 13783, 1988 - Schmiedel, mentions the leach line for septic system).

View at crossing through crown on LS shoulder from WS shoulder.
Evidence of trench visible at cut in pavement.

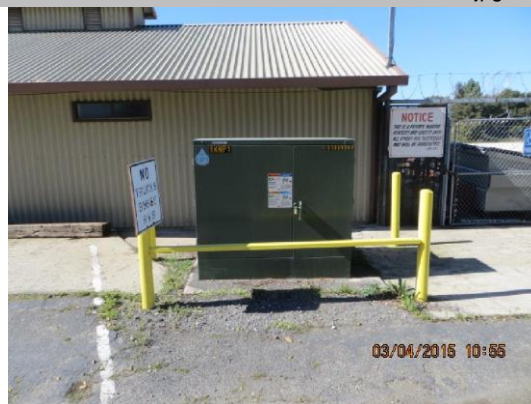
Photo 2 of 3 : UCIP_SP_2017_50159_73167.jpg

Waterside view. Unclear if there is a sewer cleanout or other evidence of pipe location on WS shoulder.

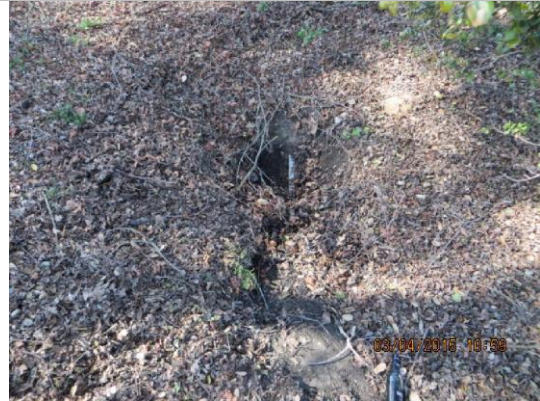
Photo 3 of 3 : UCIP_SP_2017_50159_73168.jpg

Comment Code					
Inspector Comment					
FS_ID:50159 DS_ID:18977 EP_NO: 14313 Repair Type: Urgent Crossing Status: Indicator Found UCIP Comments: 06/01/2016 Could not locate pipe. Likely buried next to leach box. Could not find signs of leaking or presence of water or erosion. Pipe may still be leaking but buried. (K. Fazel - UCIP)03/04/2015 Septic line appears to be leaking at LS toe. Erosion of soil and wet soil visible at LS toe. No septic smell accompanied other evidence at site. (W. Wylie - FPIIB) FIELD_STRUCT_DESC: 3 of 3: 2-inch galvanized steel sewer pipe through the levee, 1 foot below the crown. A metal cutoff placed around the pipe near the centerline of the levee. 4-foot by 6-foot concrete box at the landside (LS) toe. Pipe runs through the district president, Clarence Chu's property: ckchu52@comcast.net 916-776-1684, 916-813-7037. (Permit No. 14313, 1986 - Schmiedel) (Additional Related Permit(s): Permit No. 13783, 1988 - Schmiedel, mentions the leach line for septic system). FS Date: 3/4/2015 4:48:00 PM

Septic line leaking at LS toe. Erosion of soil at toe visible.

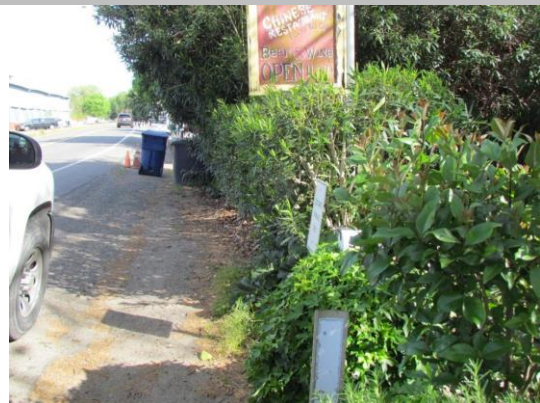
Photo 1 of 2 : SP_2017_RD0369_207_8_20170405_00023.jpg

LM Start	0.75	Rating **	U	Issue No.	8
LM End	0.77	Issue Type +	Ma	Location *	LS
Category	Earthen Levee			GPS Latitude/Longitude	
				Start	End
Item	Vegetation			38.250215 °	38.249930 °
				-121.509990 °	-121.509880 °
DWR ID	DWR_RD0369_01_s_2017_8				
Comment Code					
V7 : Trees / Woody Vegetation					
Inspector Comment					
District need to control the woody tree and vegetation growth along the lanside levee section.

Looking upstream from levee mile 0.77 to levee mile 0.75 at the woody tree and vegetation on the landside slope.
